PROPERTY INSPECTION REPORT

#555-10

INSPECTION WORK ORDER	
REPORT / ORDER NUMBER # 555-10	DATE INSPECTED 11/22/2010
CLIENT John and Jane Doe	ADDRESS INSPECTED 4103 Somewhere Ln Amarillo TX
REALTOR Anywhere Realtors	AGENT Mr. Realtor #
TITLE COMPANY The Title Company I-40 West Amarillo TX fax # 806-888-8888	CLOSING DATE 12/12/2012

ADDITIONAL INFORMATION PROVIDED BY INSPECTOR
4103 Somewhere Ln Amarillo TX

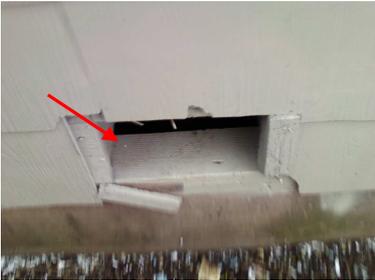
- 1. Crawlspace vent on the East side of residence is missing screen. Screens should be installed on all crawlspace vents for prevention of animal entry. (Picture provided for reference on addendum)**

- Crawlspace vent on the East side of residence is missing screen. Screens should be installed on all crawlspace vents for prevention of animal entry. (Picture provided for reference on addendum)

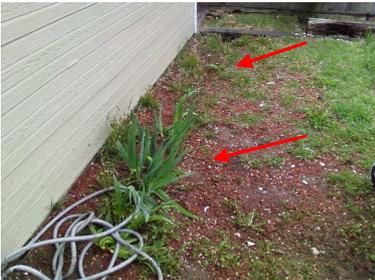
- 1. Grade on the West side of residence slopes toward foundation wall. Grade should slope away from foundation wall for proper drainage and help prevent water pooling.(Picture provided for reference on addendum)**

- Grade on the West side of residence slopes toward foundation wall. Grade should slope away from foundation wall for proper drainage and help prevent water pooling. (Picture provided for reference on addendum)

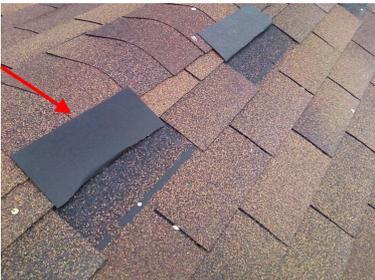
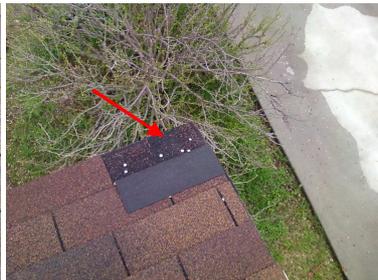
- 1. Multiple shingle tabs are damaged. All damaged shingles should be repaired for proper water shed. (Picture provided for reference on addendum)**
- 2. Hot mop edges on the East side of residence are separating from drip flashing. Edges should be sealed for prevention of water entry. (Picture provided for reference on addendum)**

- Multiple shingle tabs are damaged. All damaged shingles should be repaired for proper water shed. (Picture provided for reference on addendum)

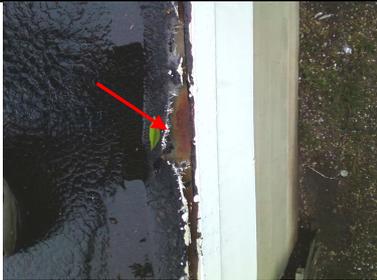
- Hot mop edges on the East side of residence are separating from drip flashing. Edges should be sealed for prevention of water entry. (Picture provided for reference on addendum)

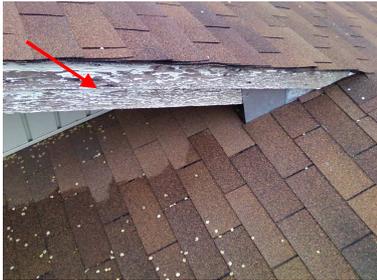
- 1. Gable on North side of residence has excessively chipped paint. All paint on wood material should be repaired to protect wood material from weather exposure. (Picture provided for reference on addendum)**

- Gable on North side of residence has excessively chipped paint. All paint on wood material should be repaired to protect wood material from weather exposure. (Picture provided for reference on addendum)

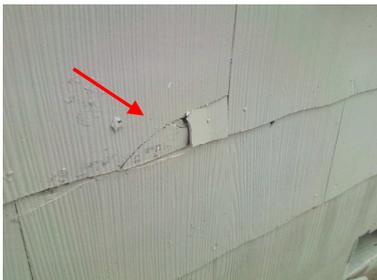
- 1. Multiple exterior asbestos/cement shingles are damaged. Damaged shingles should be repaired/replaced for proper water entry protection. (Picture provided for reference on addendum)**
- 2. Chipping paint on wood trim should be repaired to protect wood material from weather exposure. (Picture provided for reference on addendum)**

- Multiple exterior asbestos/cement shingles are damaged. Damaged shingles should be repaired/replaced for proper water entry protection. (Picture provided for reference on addendum)

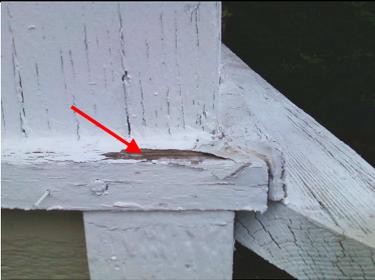
- Chipping paint on wood trim should be repaired to protect wood material from weather exposure. (Picture provided for reference on addendum)
- South West bedroom door will not close. Door is striking frame. Alignment needed for proper operation.
- South East bedroom door will not close. Door is striking frame. Alignment needed for proper operation.

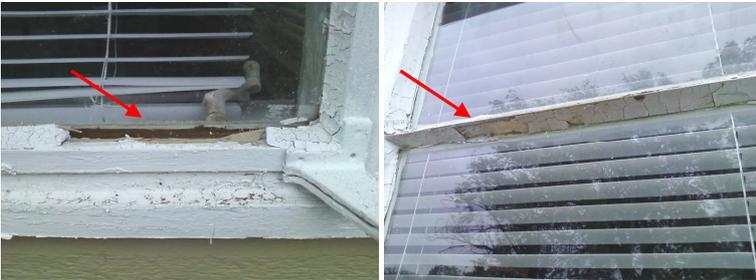
<input type="checkbox"/>	<input type="checkbox"/>	<input type="checkbox"/>	<input checked="" type="checkbox"/>	H. Windows Comments: EXTERIOR: <ol style="list-style-type: none"> 1. Windows have chipping paint and damaged window glazing. All areas should be repaired for proper water shed and protection. (Picture provided for reference on addendum) SOUTH EAST BEDROOM: <ol style="list-style-type: none"> 1. East windows crank and latch are missing. Repair needed for proper operation. 2. South Window crank is missing. SOUTH WEST BEDROOM: <ol style="list-style-type: none"> 1. West walls southern window crank is stripped. Repair needed for proper operation. 2. West walls Northern window crank is missing. 3. Window pane is cracked. (Picture provided for reference on addendum)
--------------------------	--------------------------	--------------------------	-------------------------------------	--

- Windows have chipping paint and damaged window glazing. All areas should be repaired for proper water shed and protection. (Picture provided for reference on addendum)

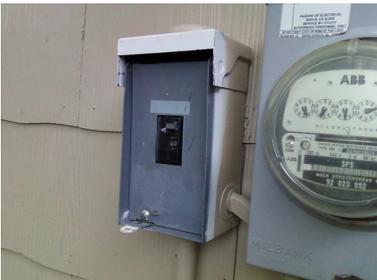
- 1. Air conditioning units disconnect cover is missing. (Picture provided for reference on addendum)

- Air conditioning units disconnect cover is missing. (Picture provided for reference on addendum)

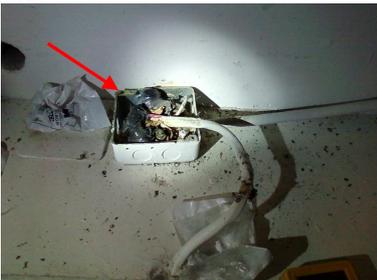
KITCHEN:

- 1. Wiring under cabinets is missing junction box cover. Wiring should be installed in conduit for protection from damaged and properly secured to junction box. (Picture provided for reference on addendum)
- 2. Wiring in handing cabinets should be installed in conduit for prevention of damaged. (Picture provided for reference on addendum)
- 3. East counter top receptacles do not have power.
- 4. North wall receptacle does not have power.
- 5. 220v plug should be securely mounted to wall and knock out is missing. (Picture provided for reference on addendum)

- Wiring under cabinets is missing junction box cover. Wiring should be installed in conduit for protection from damaged and properly secured to junction box. (Picture provided for reference on addendum)
- Wiring in hanging cabinets should be installed in conduit for prevention of damaged. (Picture provided for reference on addendum)
- East counter top receptacles do not have power.
- North wall receptacle does not have power.

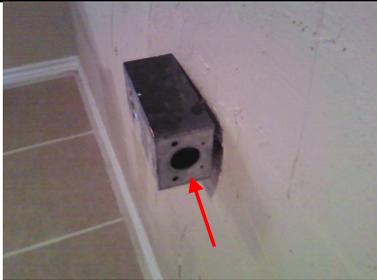
- 220v plug should be securely mounted to wall and knock out is missing. (Picture provided for reference on addendum)

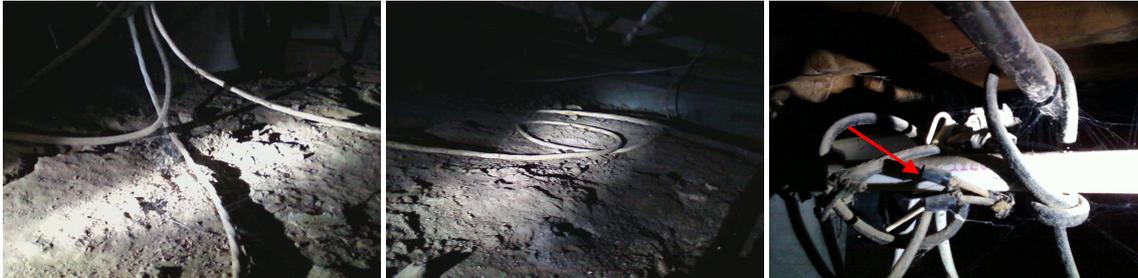
CRAWLSPACE

- Multiple wires are laying on grade in crawlspace. All wiring should be elevated, and secured from grade for safety. Connections should be within junction boxes for safety. Wiring should NOT be wrapped around plumbing lines for support. (Picture provided for reference on addendum)

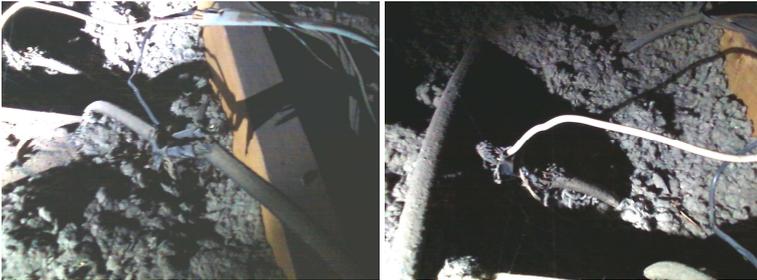
ATTIC

- Wire connection's) in attic space are NOT within junction boxes. All wire connections in attic space should be in capped junction boxes for safety. (Picture provided for reference on addendum)

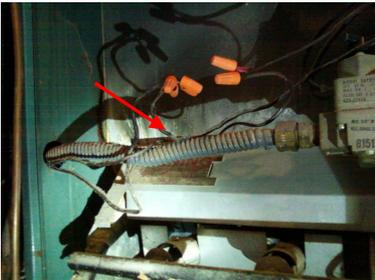
- Flex gas line penetrates heating unit shell. Unit should be supplied with rigid pipe from the gas valve to the exterior of the unit for safety. (Picture provided for reference on addendum)

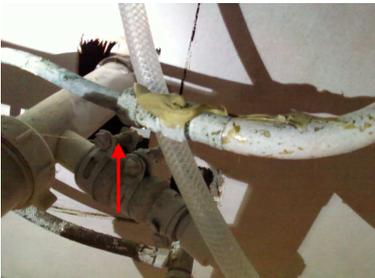
- Cold water supply line is leaking at connection. (Picture provided for reference on addendum)

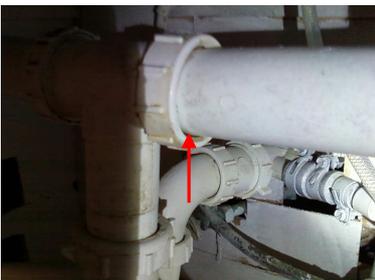
- Drain line is leaking at nut. (Picture provided for reference on addendum)

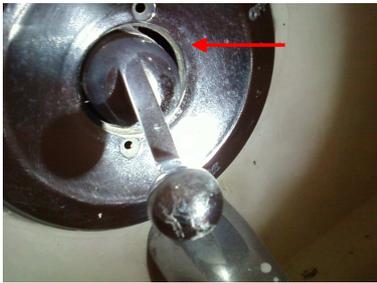
- Tubs faucet handle escutcheon is improperly sized for handle. Large openings around handle can allow water entry behind material and cause damage. Repair needed. (Picture provided for reference on addendum)

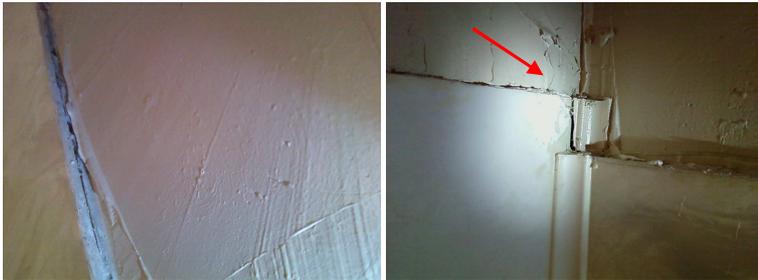
- Back tub surround wall is loose to wall and gapped at top at wall intersection. Repair needed for prevention of water entry behind material. (Picture provided for reference on addendum)

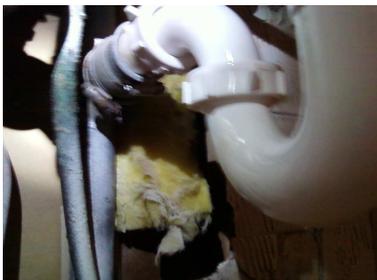
- Sink drain line is leaking at nut connection. (Picture provided for reference on addendum)

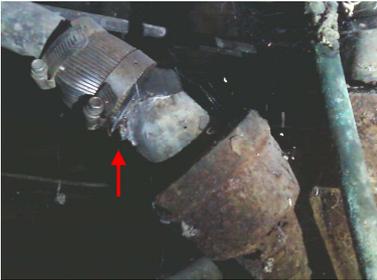
CRAWLSPACE:

- 1. Drain line is leaking at rubber coupling connection. (Picture provided for reference on addendum)**
- 2. Drain stack began to leak while operating all water fixtures. It is my guess that the main drain line is partially clogged and water was backing up during excessive water consumption. Recommend further evaluation of main drain lines to determine appropriate repairs. (Picture provided for reference on addendum)**

- Drain line is leaking at rubber coupling connection. (Picture provided for reference on addendum)
- Drain stack began to leak while operating all water fixtures. It is my guess that the main drain line is partially clogged and water was backing up during excessive water consumption. Recommend further evaluation of main drain lines to determine appropriate repairs.

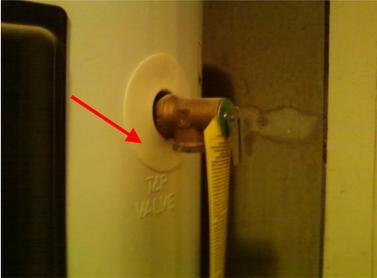
1. **Hot Water heater T & P (Temperature and Pressure) relief valve is not plumbed. Valve should be plumbed to the exterior of home in the event of pressure relief. (Picture provided for reference on addendum)**
2. **Temperature and Pressure relief valve is leaking. Replacement needed.**
3. **Recommend a drain pan be installed under the water heating unit for added protection in the event of a water heater leak. (Picture provided for reference on addendum)**
4. **Electrical connections to top of unit are not properly secured to tank. Repair needed for safety. (Picture provided for reference on addendum)**

- Hot Water heater T & P (Temperature and Pressure) relief valve is not plumbed. Valve should be plumbed to the exterior of home in the event of pressure relief. (Picture provided for reference on addendum)
- Temperature and Pressure relief valve is leaking. Replacement needed.

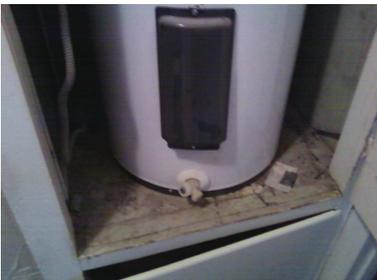
- Recommend a drain pan be installed under the water heating unit for added protection in the event of a water heater leak. (Picture provided for reference on addendum)

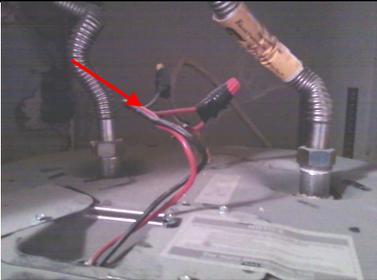
- Electrical connections to top of unit are not properly secured to tank. Repair needed for safety. (Picture provided for reference on addendum)
